Development and testing of a prototype straw bale house

This paper describes the research, development, construction and initial testing of an innovative low-carbon prototype house built using novel prefabricated straw bale panels. The use of straw as insulation provides an opportunity for value-added use of a widely available low-carbon co-product of farming. The research reported in the paper seeks to enhance the understanding and develop the modern mainstream acceptance and use of straw as a construction material in housing and other applications. The paper initially summarises development and construction of the panels and the house. Tests conducted on the panels and house reported in the paper include on-going durability assessment, fire resistance testing, acoustic transmittance testing, air permeability tests and thermal surveys.

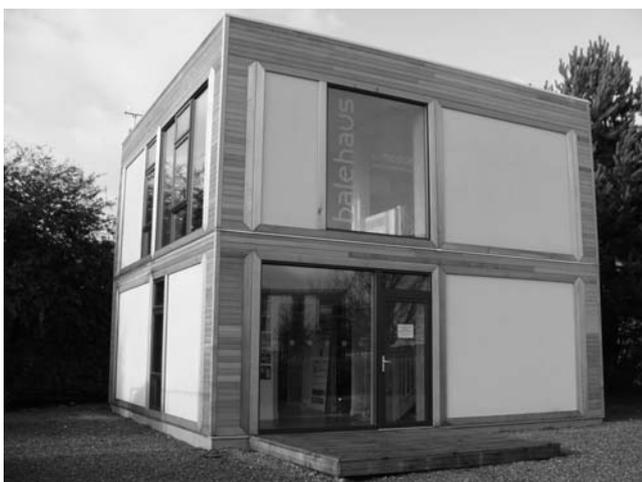
Figure 1. Prototype house

ModCell employs prefabrication as a method of construction using straw to provide panels for cladding and, more recently, load-bearing walls (see Figure 1). Straw bale benefits from the general advantages of prefabrication, including: improved quality; reduced construction time on site; minimisation of waste; and safer construction. However, very importantly prefabrication reduces the risk of weather delays and the straw becoming wet during

The load-bearing panels have been utilised for a prefabricated straw bale housing concept, known as BaleHaus. The first house constructed using this system in its entirety has been built on the University of Bath campus and is known as the BaleHaus @ Bath. This prototype house is being monitored and evaluated as part of a Technology Strategy Board (TSB) funded research project being undertaken at the university. The

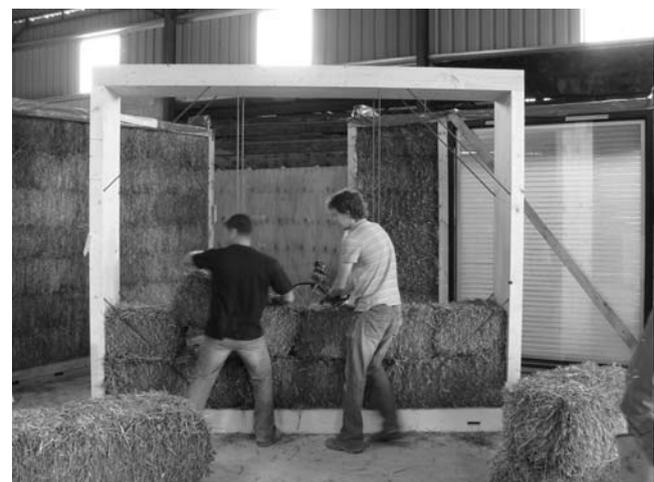
Figure 2. Panel construction process in ‘flying factory’

The prefabricated straw bale panel frames are constructed using engineered (glue-laminated or cross laminated) softwood timber. These open-sided frames are in-filled with straw bales (Figure 2) that are staked with timber poles. The straw bales are pre-compressed vertically within the frames using a fork-lift. Over seven courses the bales are typically compressed by 80–100 mm (depending on original size). Pre-compression of the straw is not significant for structural performance of the panels, but provides a stable substrate for the renders and prevents subsequent settlement and formation of gaps. The frames are braced with stainless steel bars. Once filled with straw the panels are spray rendered with three coats of formulated lime render, to a thickness of 30–35 mm. The render provides a water vapour permeable system, allowing moisture to transfer through and preventing humidity build-up

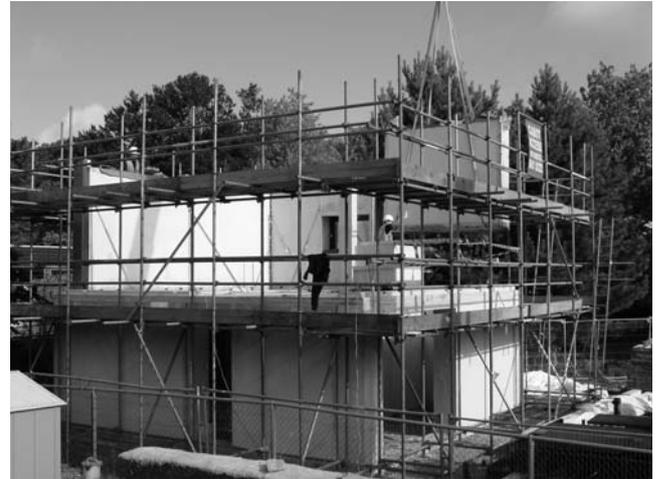
Figure 3. Construction of prototype house

The prototype house was constructed in the summer of 2009, with research monitoring starting at the end of September in the same year. The house was built using eight new panels built in a 'flying factory' 6 km away from the site and eight panels reused from a previous exhibition project, where they made up the ground floor. The house was designed, for monitoring purposes, with two bedrooms downstairs and an open-plan living/dining area and kitchen upstairs. The construction of the prototype house was built onto a conventional reinforced concrete slab foundation. A timber sole plate was attached to the slab which the ground floor panels sit on once craned into place, along with the four corner boxes filled with straw. The cross-laminated solid timber floor plate was then craned into position and another sole plate fixed to this for the first floor panels to sit on. Once the first floor panels were craned into place, as shown in Figure 3, the cross-laminated solid flat timber roof was installed, insulated with wood fibre insulation board and covered with a recycled waterproof membrane. Along the vertical edges between the wall panels, 20 mm of wood fibre insulation was inserted and the panels were fixed together using long screw connections, sealed with airtight tape and zipped together to provide structural integrity both internally and externally using plywood strips. Western red cedar cladding was then applied to the exterior of the house and construction was completed when the floors were insulated with wood fibre insulation and finished.

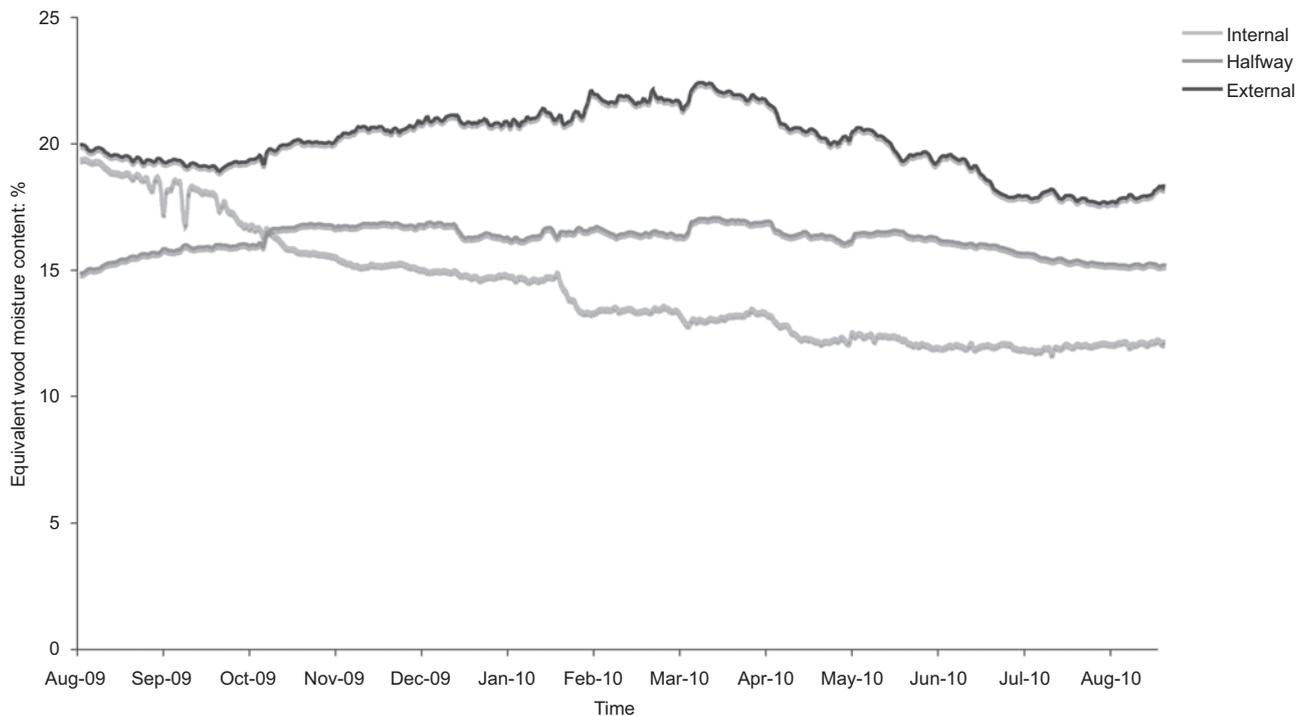
Figure 4. Wood moisture equivalent through straw in prefabricated panels

Initial data from the timber moisture equivalent sensors are shown in Figure 4, covering the period from construction of the prototype house in September 2009 to July 2010. Although the moisture content of the embedded small (Douglas fir) timber block (measuring approximately 60 × 25 × 10 mm) will not respond to changes in environmental conditions as quickly as the lighter straw, it will show longer-term trends in moisture conditions. Initially the moisture contents of sensors on the faces are higher than the moisture contents of those embedded in the middle of the panel; this is attributed to moisture from the lime rendering. By October 2009 the moisture profile shows highest moisture levels at the external face and lowest on the internal face. During early summer months the moisture content has reduced significantly. Over the monitoring period, 435 mm of rainfall was recorded at the site, with only 46 mm falling after 1 May 2010. Over the monitoring period the average daily timber moisture contents did not exceed 22%. Prolonged moisture contents above 25% are considered a significant risk factor for straw durability (Summers, 2006). Further data from moisture monitoring will be reported at a later date.

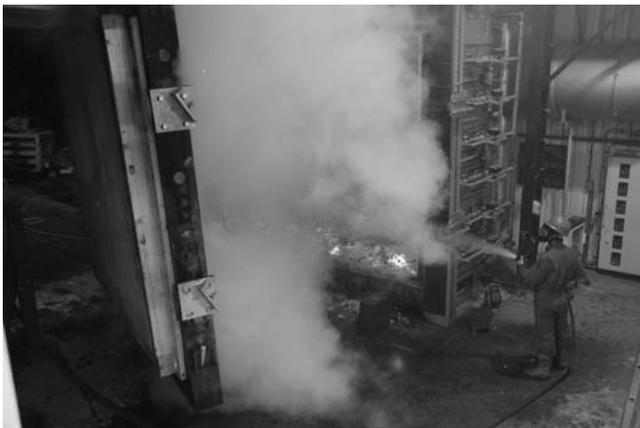
Figure 5. Panel being removed from furnace after fire test (Chiltern International Fire, 2009)

reached an average of 1065°C at 135 min (Chiltern International Fire, 2009). The temperatures monitored on the outer surface of the panel started at 12–14°C and raised to 36–60°C (Chiltern International Fire, 2009). The panel was removed from the furnace after the test was stopped (Figure 5), hosed down and inspected. The straw exposed to the furnace had charred black in a similar manner to the timber, although at a faster rate. On the side still covered in render, once some of this was removed, yellow straw was still visible.

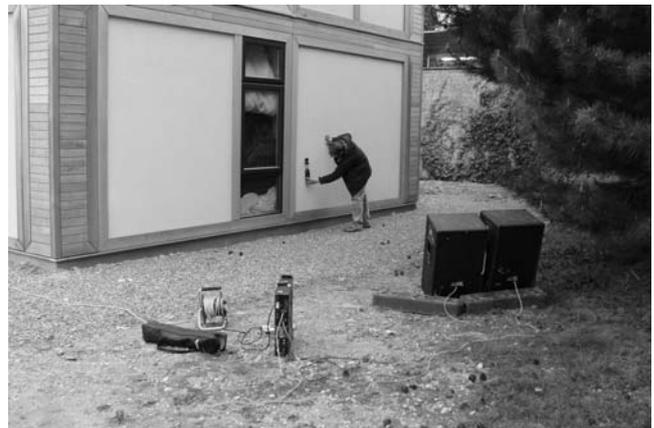
Figure 6. Sound insulation performance test being conducted on prototype house

A second sound insulation test was undertaken on the prototype house, shown in Figure 6, on 14 May 2010 in accordance with ISO 140-5:1998 (BS EN ISO 140-5:1998, (BSI, 1998)). The aim of this test was to investigate the sound insulation performance of the prototype house and to verify the results from the previous test. The test was carried out by emitting 100 dB of ‘white noise’ to the exterior of the house and its volume was measured on the exterior face of the building and in an isolated room inside the house. The isolated room was created in an attempt to exclude all sound leakage through the window and partitions. The window was sealed using two layers of sound insulation board, which were held in place by a frame around the window but were arranged in such a way that vibrations could not flow from the timber frame to the internal space. Background noise within the isolated room was also measured when the ‘white noise’ was not being emitted. The measurements were used to calculate a sound level drop, R_w value, of 44 dB (Mach Acoustics, 2010).

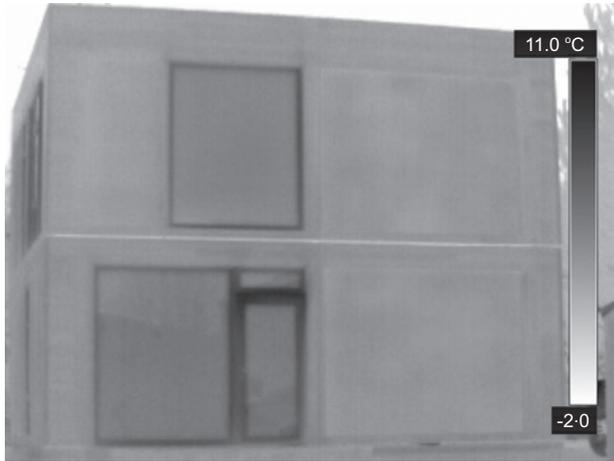
Figure 7. External thermal image of east façade (InfraRed Vision, 2010, p. 8)

A thermal image of the external east façade, shown in Figure 7, shows no sign of heat loss, thermal bridging or building defects of the building envelope. It does, however, highlight some heat loss around the door, which was thought might be due to ineffective seals. Externally there were two images which showed small amounts of heat loss through the fabric of the BaleHaus; these were from the left-hand side of the window on the north façade, which was also seen internally as air infiltration. The cladding at the top right-hand corner of the west façade was the second incidence which showed a small amount of heat loss, again seen internally as air infiltration.

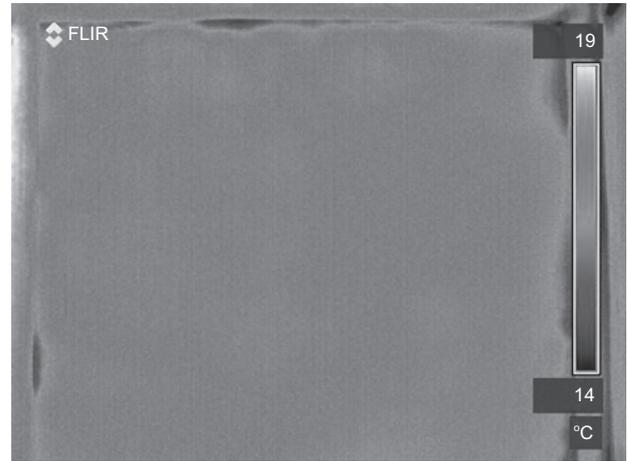
Figure 8. Internal thermal image of first floor, right-hand panel on the south façade (InfraRed Vision, 2010, p. 34)

Internally the panels showed uniform temperatures across their surfaces with some air infiltration around the edges; this is shown in Figure 8, an image of the first floor, right-hand panel on the south façade. The image also shows no sign of cold air bridging between the bales within the panel. Internally there were a number of incidences where air infiltration was identified as being present on more than one occasion, including: around the ply surround of the panels; at junctions between panels; through the window and door frame support; around the timber frames; and at both ends of the support beam.
